**ORMOND BEACH
MUNICIPAL
AIRPORT (OMN)**

JUNE 2015

STATEWIDE
**Airfield
Pavement
Management**
PROGRAM

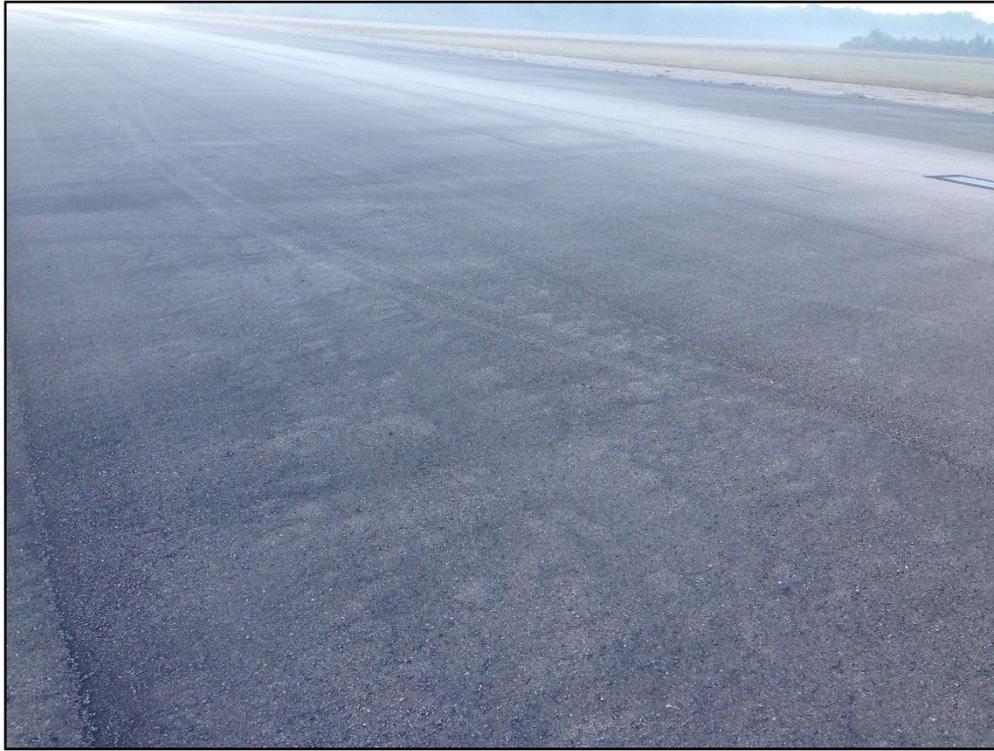
Runway 17-35, Section 6205, Sample Unit 164 – Low Severity (56) Swelling, Low Severity (52) Raveling, Low Severity (57) Weathering

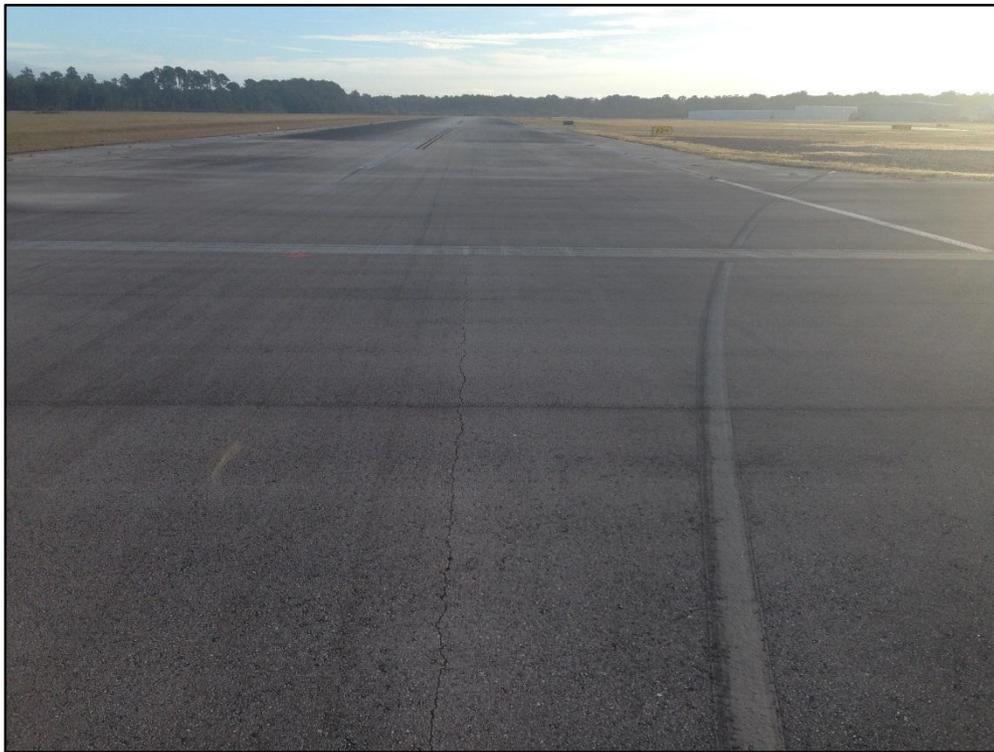
Runway 17-35, Section 6205, Sample Unit 148 – Low Severity (48) Longitudinal and Transverse Cracking, Low Severity (52) Raveling, Low Severity (57) Weathering

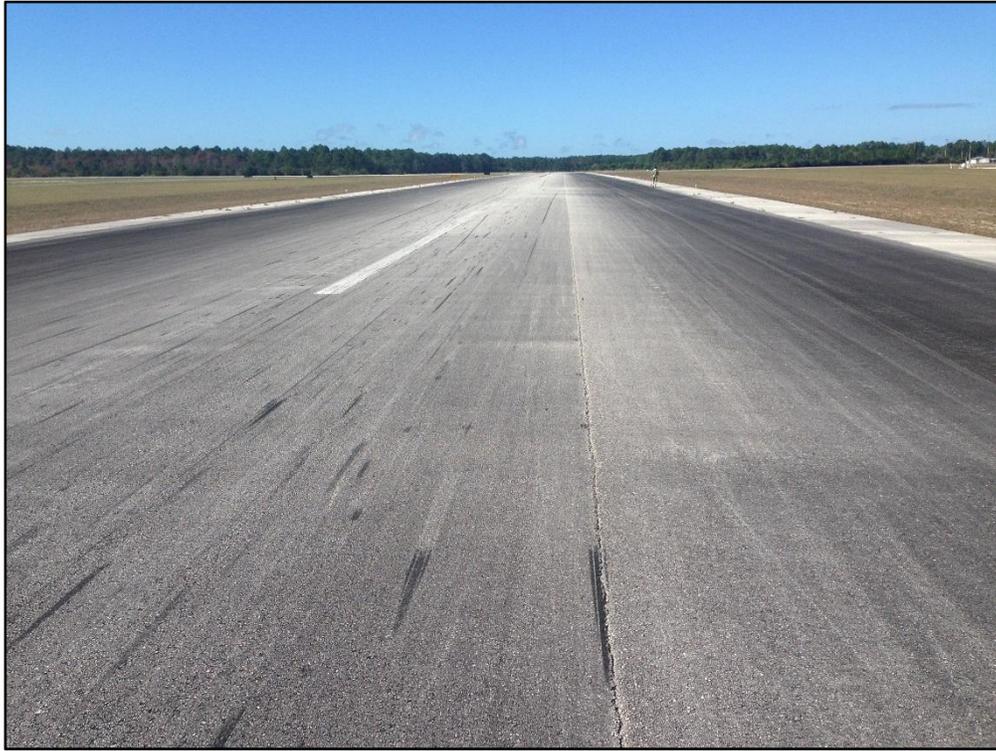
Runway 8-26, Section 6105, Sample Unit 166 – Low Severity (48) Longitudinal and Transverse Cracking, Low Severity (52) Raveling

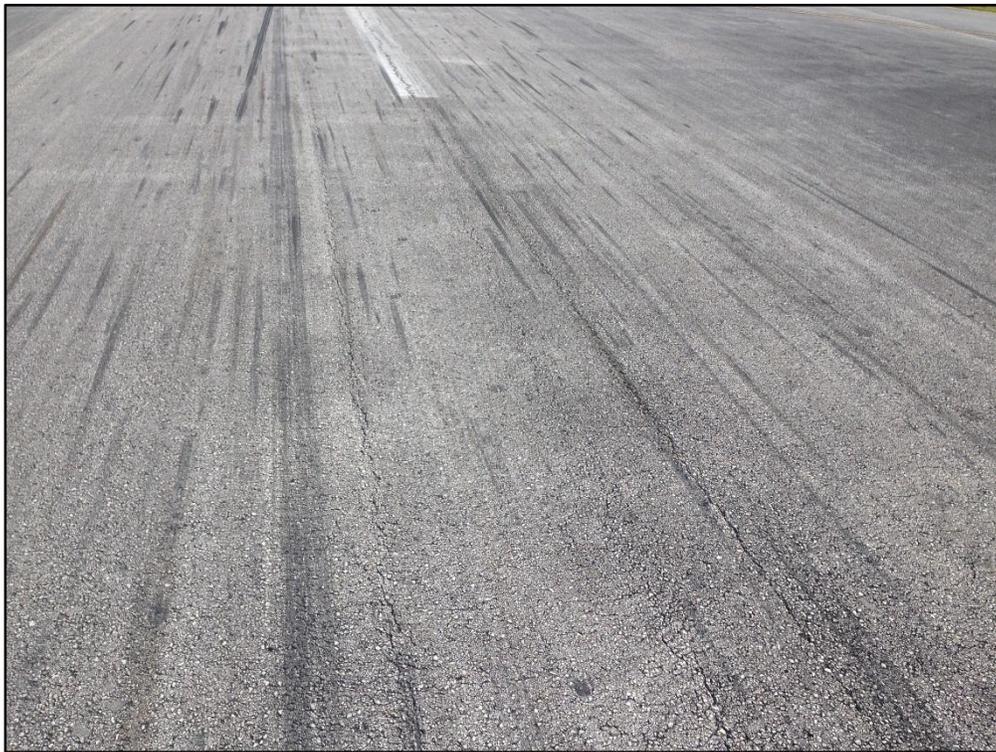
Runway 8-26, Section 6105, Sample Unit 117 – Low Severity (48) Longitudinal and Transverse Cracking, Low Severity (52) Raveling

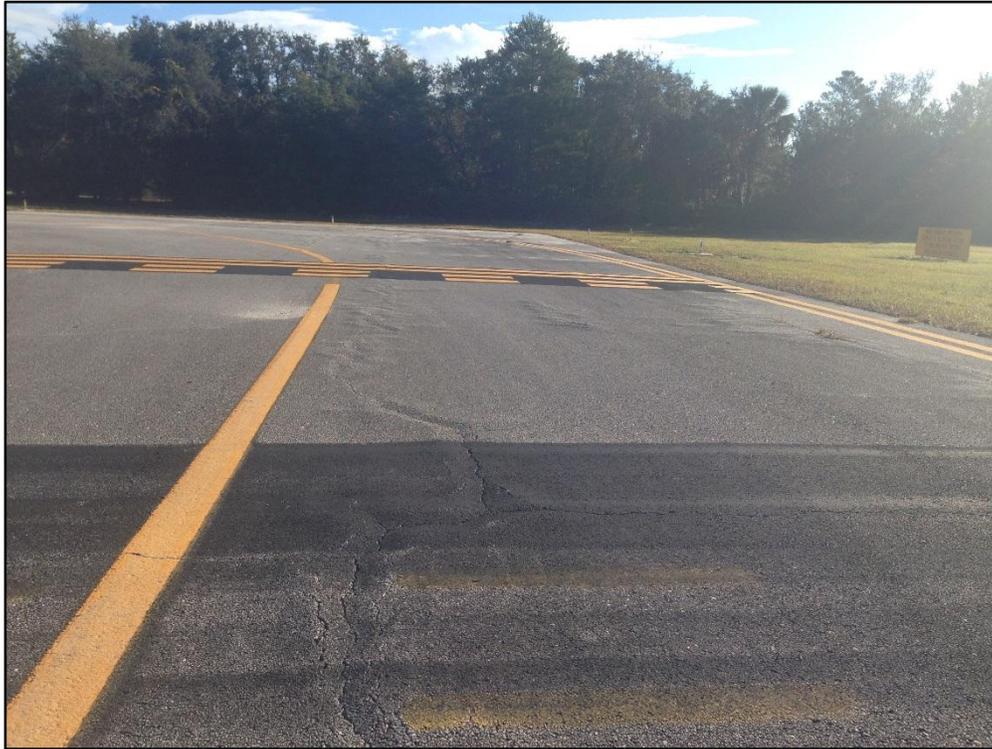
Taxiway Foxtrot, Section 650, Sample Unit 100 – Low Severity (56) Swelling, Medium Severity (56) Swelling, Low Severity (48) Longitudinal and Transverse Cracking, Medium Severity (48) Longitudinal and Transverse Cracking, Low Severity (52) Raveling

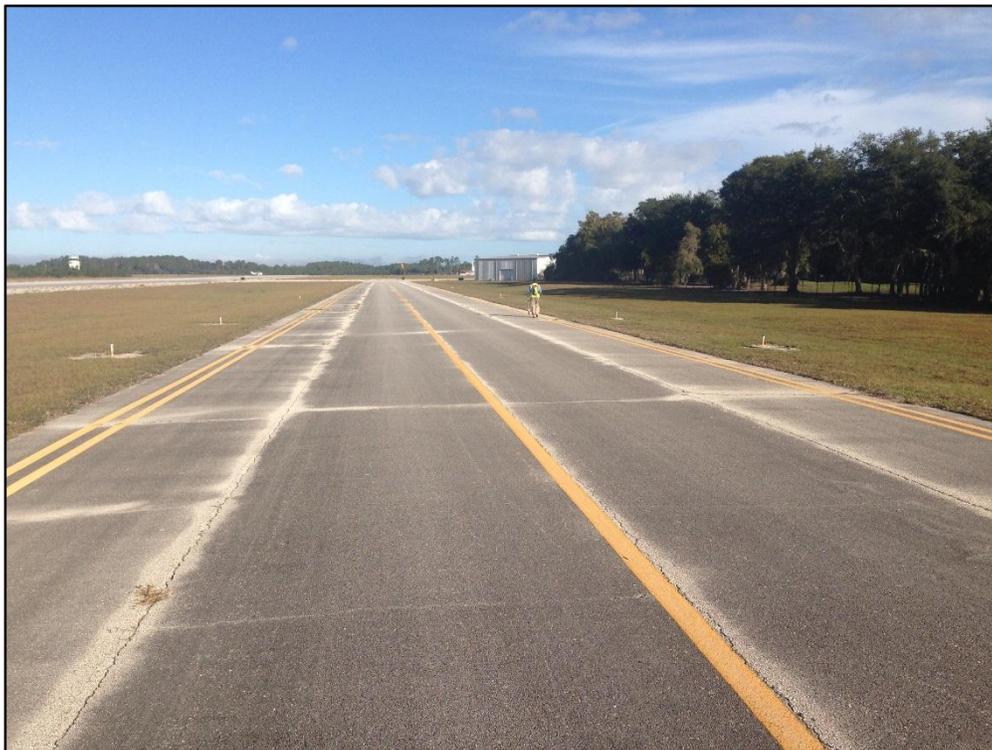
Taxiway Foxtrot, Section 605, Sample Unit 103 – Low Severity (48) Longitudinal and Transverse Cracking, Medium Severity (48) Longitudinal and Transverse Cracking, Low Severity (43) Block Cracking, Low Severity (56) Swelling, Low Severity (52) Raveling

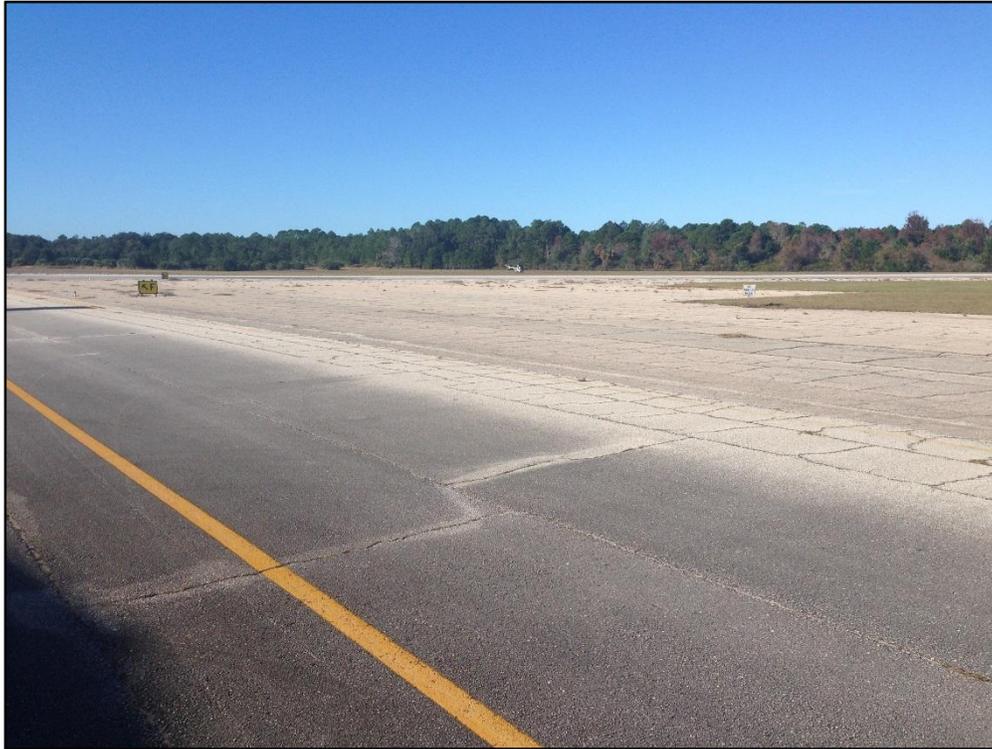
Taxiway Delta, Section 405, Sample Unit 103 – Medium Severity (43) Block Cracking, Medium Severity (48) Longitudinal and Transverse Cracking, Low Severity (52) Raveling

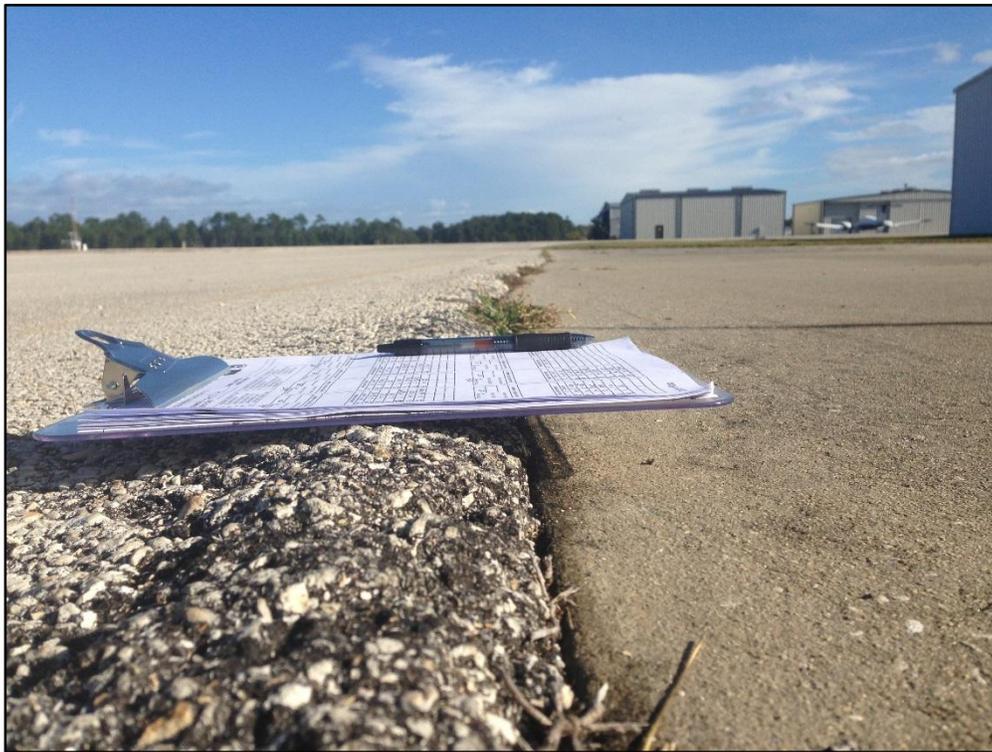
Taxiway Delta, Section 405, Sample Unit 107 – High Severity (54) Shoving, Low Severity (52) Raveling

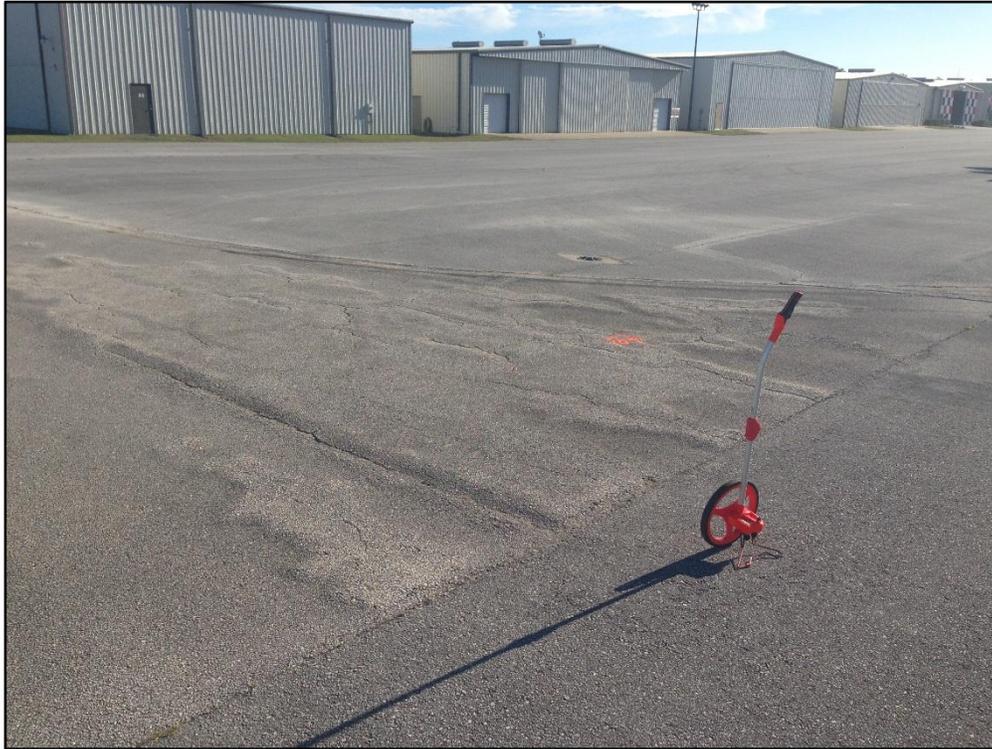
Taxiway Delta, Section 405, Sample Unit 109 – Medium Severity (56) Swelling, Low Severity (48) Longitudinal and Transverse Cracking, Medium Severity (48) Longitudinal and Transverse Cracking, Low Severity (52) Raveling

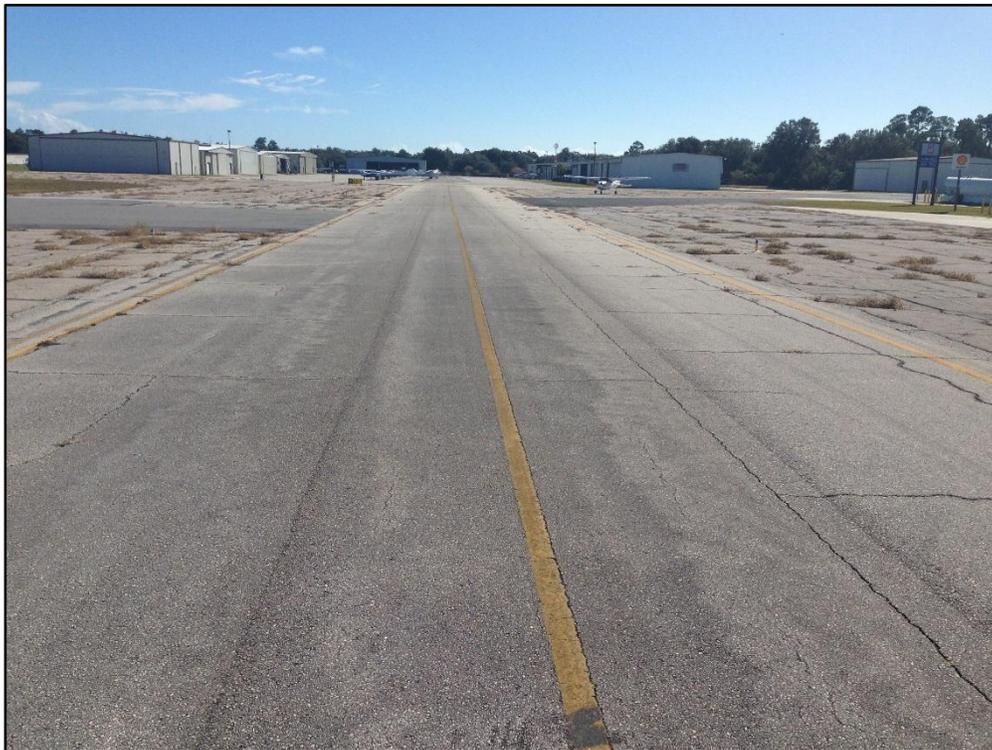
Taxiway Bravo, Section 205, Sample Unit 105 – Medium Severity (43) Block Cracking, Low Severity (48) Longitudinal and Transverse Cracking, Medium Severity (48) Longitudinal and Transverse Cracking, Low Severity (52) Raveling, Low Severity (56) Swelling

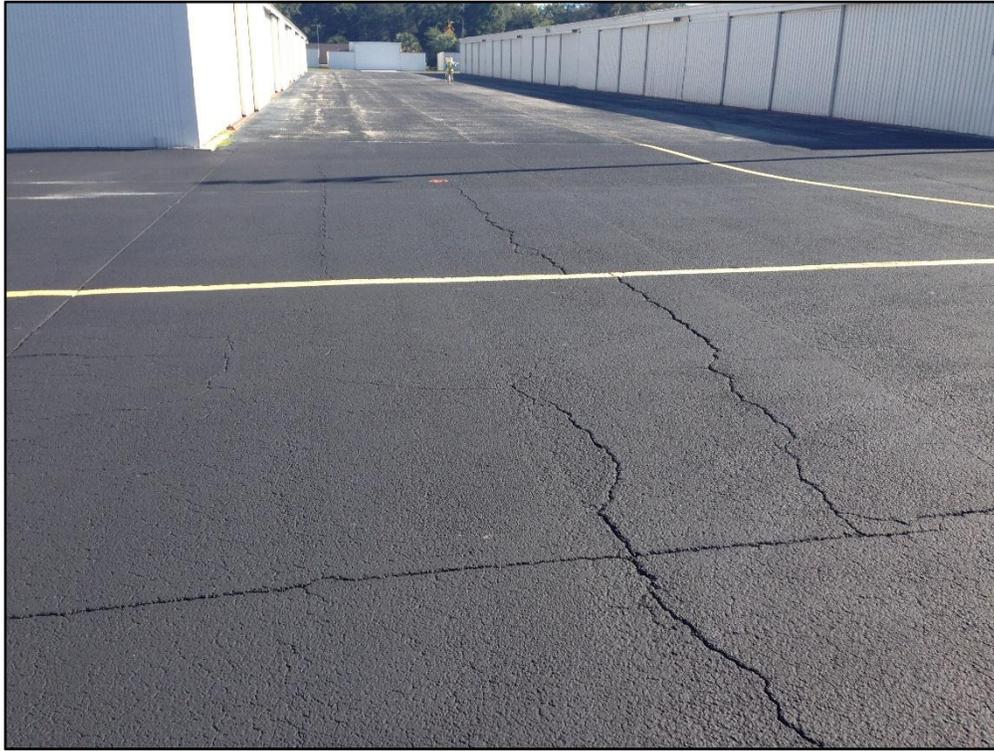
Apron Center, Section 4205, Sample Unit 111 – Low Severity (48) Longitudinal and Transverse Cracking, Medium Severity (48) Longitudinal and Transverse Cracking, Low Severity (52) Raveling

- Center Apron – Sections 4204 and 4205
 - Mill and Overlay and Reconstruction attributed to load, climate, and age of pavement.
- East Apron – Section 4305
 - Reconstruction attributed to load, climate, and age of pavement.
- West Apron – Section 4102
 - Reconstruction attributed to load, climate, and age of pavement.
- Taxiway B – Section 205
 - Reconstruction attributed to load, climate, and age of pavement.
- Taxiway D – Section 405
 - Mill and Overlay attributed to climate and age of pavement.
- Taxiway E – Section 505
 - Mill and Overlay attributed to climate and age of pavement.
- Taxiway F – Sections 605 and 650
 - Mill and Overlay attributed to climate and age of pavement.

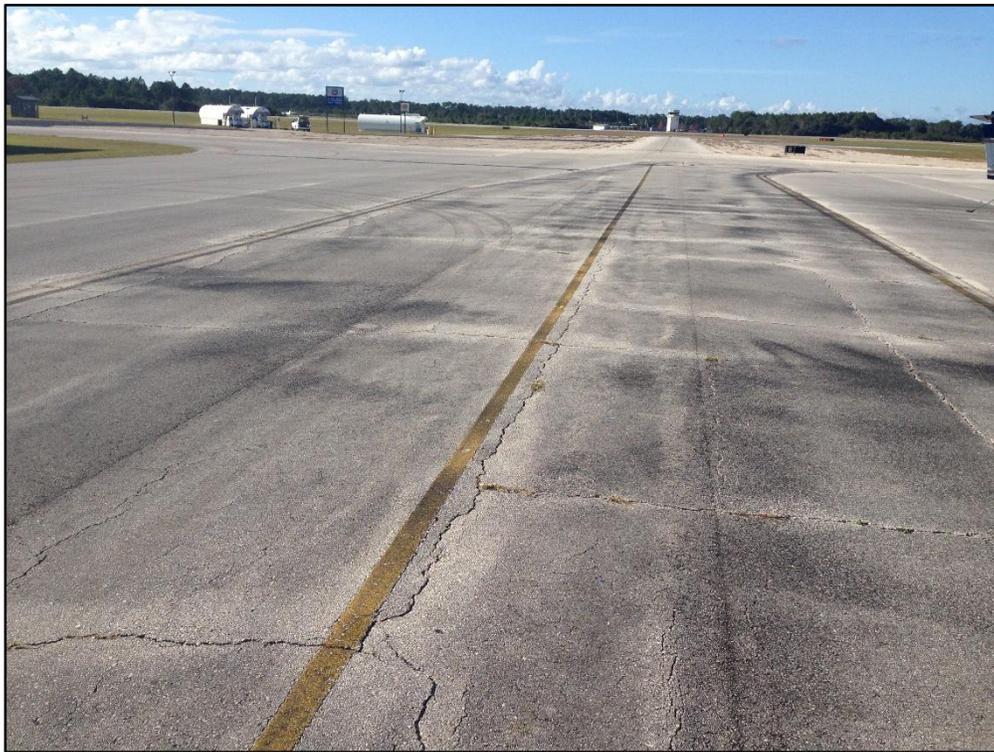
Apron West, Section 4102, Sample Unit 101 – Medium Severity (43) Block Cracking, Low Severity (56) Swelling, Low Severity (52) Raveling, Low Severity (57) Weathering
