**ORMOND BEACH
MUNICIPAL
AIRPORT (OMN)**

JUNE 2015

STATEWIDE
**Airfield
Pavement
Management**
PROGRAM

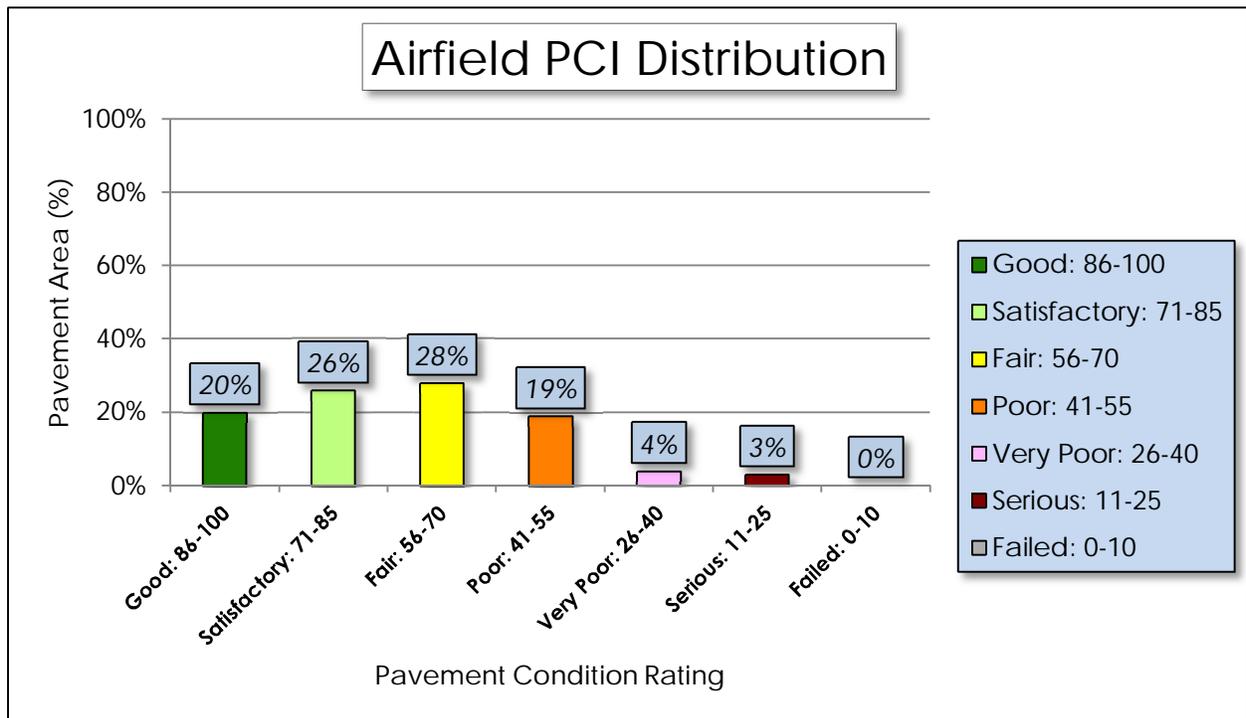
Figure 3-1: Airfield Pavement Condition Index Rating Summary

The pavement condition at Ormond Beach Municipal Airport is represented in Figure 3-1 in accordance with the condition categories and PCI scale referenced in ASTM D 5340. Further detail is provided in Table 3-3 which describes the breakdown of the airport’s airfield conditions according to area and use.
